# Zinc Whiskers Growing on Raised-Floor Tiles Are Causing Conductive Failures and Equipment Shutdowns

By Robert Sullivan, Ph.D.

TUI 813A

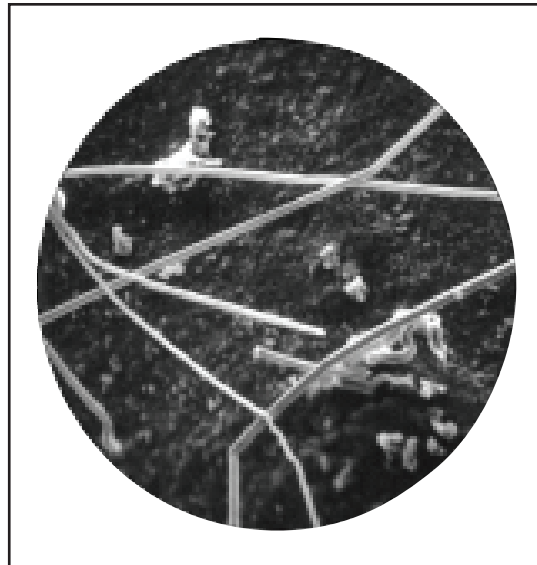
high rate of failure is unusual since the whiskers completely vaporize at only 15 mA to 25 mA (milliamps), which usually is not sufficient current to cause shorting within a power transistor. Further investigation indicates these failures were from perturbations in the control circuitry of the power supplies, which allowed a short to occur between the voltage and ground planes of the transistor. Another phenomenon observed within power supplies is the ionization of air between two closely spaced high-voltage lands on a printed circuit board. The whisker is vaporized, creating an arc path across adjacent etchings on the board.

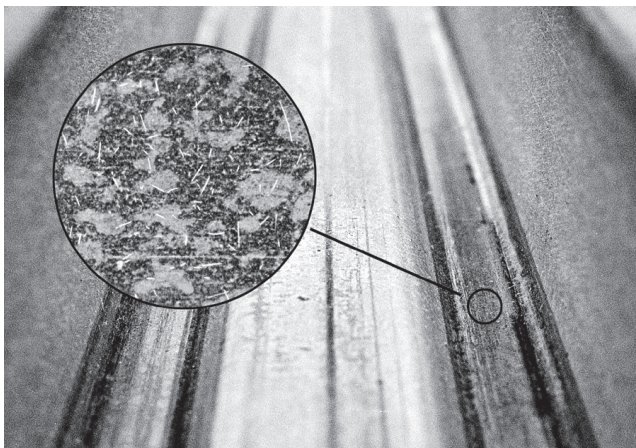
grow whiskers, while a dull-gray surface indicates the presence of whisker growth. This is not an absolute determination, however, so a closer examination is required. Tip the suspected tile upright and examine the bottom and sides using a high-intensity light - either a work light or a bright flashlight will do. Position the light at various angles to the tile surfaces and look for tiny sparkles or twinkling. If present, there is a good chance the tiles are contaminated with Zinc Whiskers. Examine at least twenty-five tiles and the stringers supporting them before concluding that electroplated-zinc material is or is not present.

If evidence of Zinc Whiskers is found, carefully examine the entire raised floor to determine the extent of the contamination exposure. The level of risk will determine the recovery plan of action. If contamination is ten percent or less of the raised floor, purchase new HDG tiles and carefully install them in the room while the equipment remains operating. Dispose of contaminated tiles in sealed plastic trash bags, and contract to have the room thoroughly cleaned.

If the raised floor is grossly contaminated, define a more detailed work plan for replacing larger sections of floor or all the tiles. Identify areas of the floor to be replaced, move equipment as needed to isolate the affected areas, and be extraordinarily careful not to disturb any loose whiskers as you proceed with the cleanup.
